2017 Annual Review

New Berrima Clay/Shale Quarry Project Approval: PA08_0212

February 2018

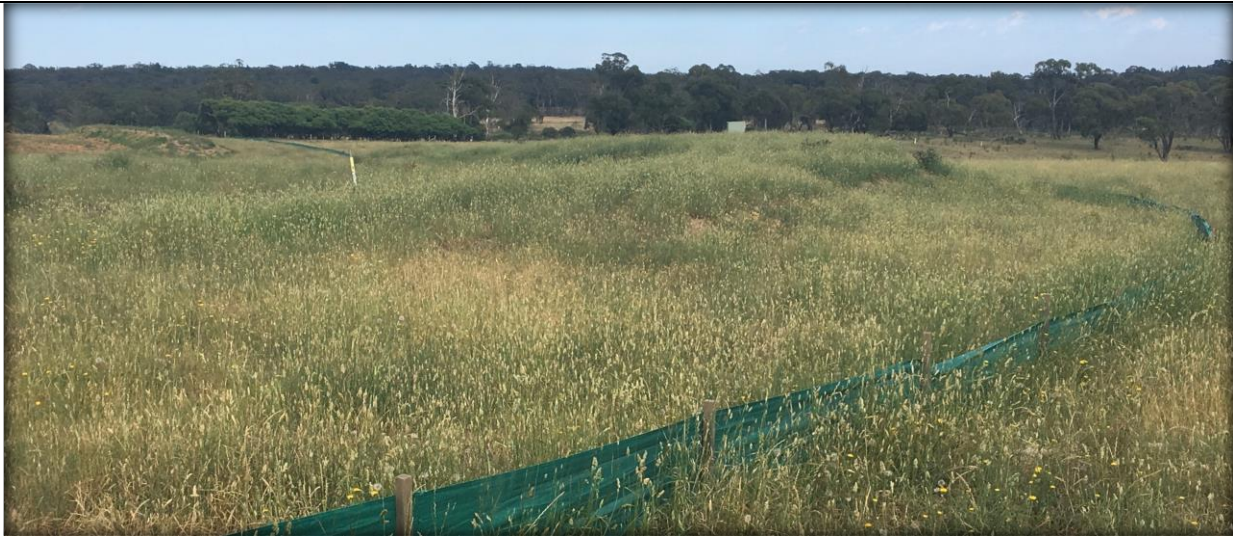
No soil stripping operations were undertaken, and no soil material was spread. A total of approximately 700m³ of topsoil material is currently stockpiled from physical commencement operations undertaken in 2016. The location of these stockpiles is shown on **Figure 4** and a photograph from December 2017 is shown as **Plate 1**.

Plate 1: View West of Soil Stockpiles – December 2017
(Foreground: Good Pasture Growth, Background: Pasture Improving)
Source: Austral Bricks

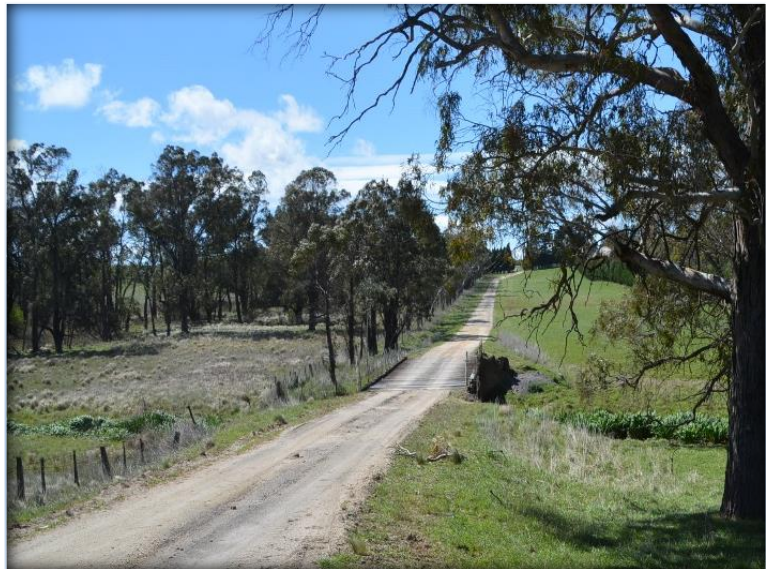
Plate 2: Original Timber Bridge - 2016
Ref: E744Q_049

The replacement of the bridge crossing Stony Creek was undertaken between August and October 2017. The replacement was undertaken in accordance with the Modification 2 approval and involved the removal of the timber from the existing bridge before the metal trusses were lifted off and onto a flatbed truck using a small crane. All material from the old bridge was removed by Dunsteel for recycling. The new steel bridge span was then lifted onto the existing abutments and concrete pumped onto the span to form the concrete deck and approaches.

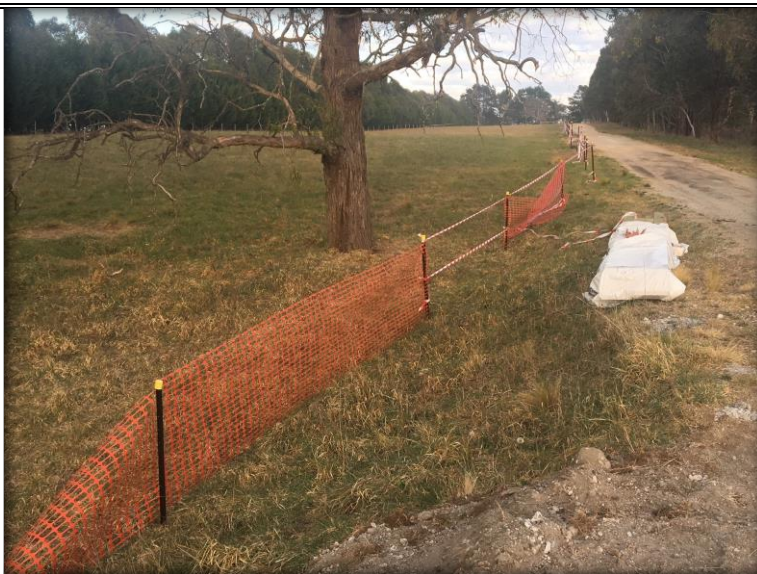
Plate 3: Fencing to Restrict Access to Heritage Sensitive Area
Source: Austral Bricks

All activity was contained to the roadway and immediately adjacent fill batters. This area was defined by the Illawarra Local Aboriginal Land Council as previously disturbed areas not containing potential heritage constraints. All works were completed with a 5t excavator, small crane, flatbed truck and concrete truck. High visibility fencing was installed to ensure accidental access did not occur beyond the 'safe' area defined the Illawarra LALC and sediment fencing placed in case of rain causing wash from the road surface. No disturbance of or access to the creek bed or banks was required. Photographs of these works are provided as **Plates 2 to 6**.

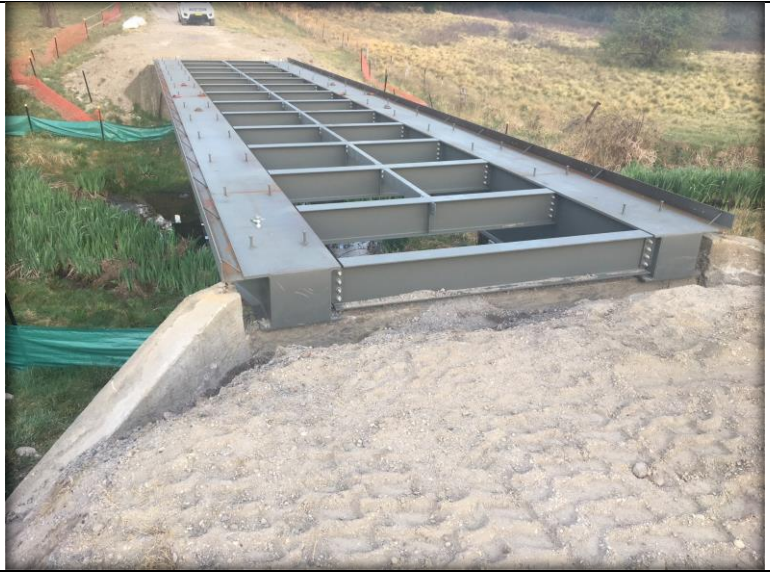
Plate 4: New Steel Bridge Span
Source: Austral Bricks

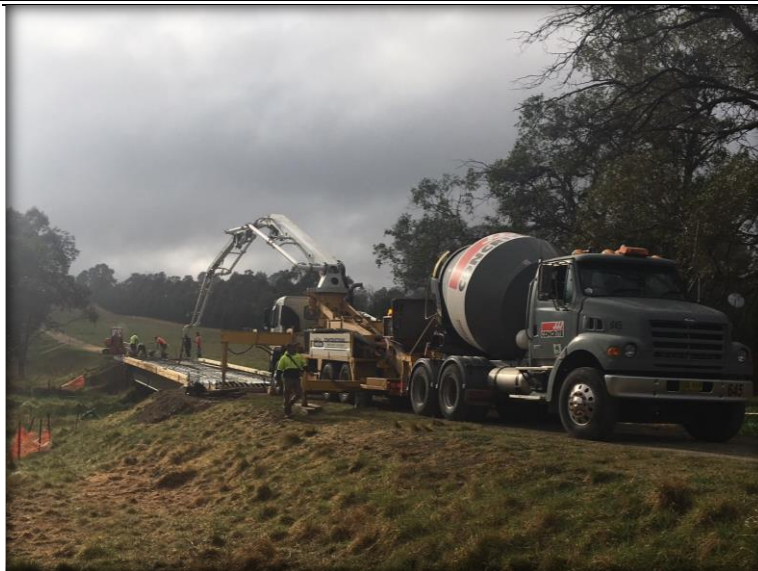
Plate 5: Crane and Concrete Truck
Source: Austral Bricks

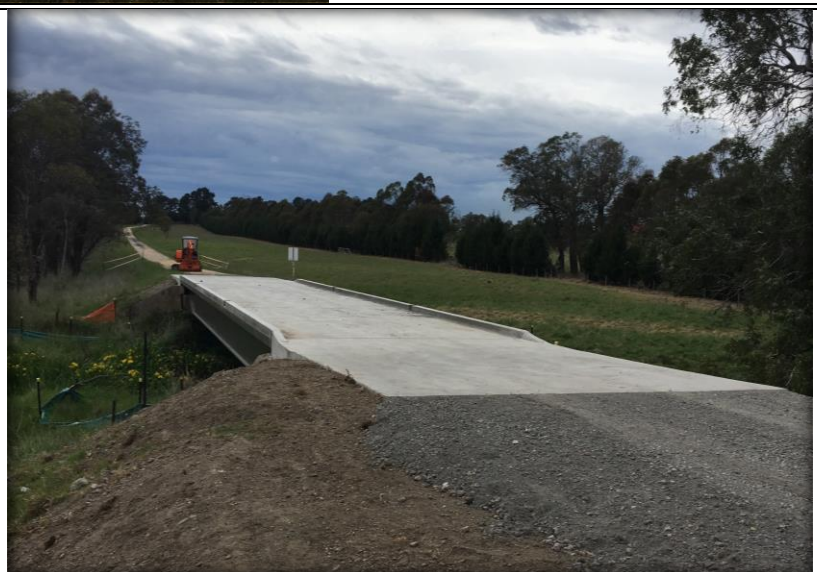
Plate 6: Completed Bridge
Source: Austral Bricks

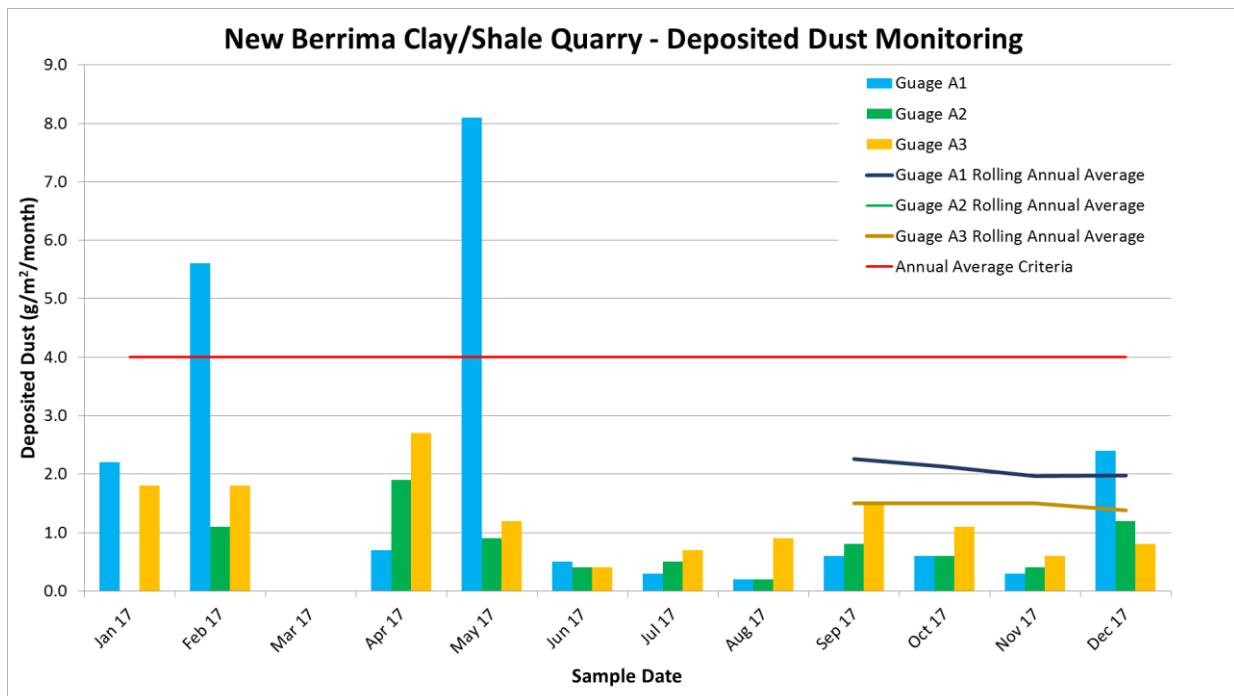
Figure 8
Deposited Dust Monitoring Results

Notwithstanding this result, the annual average monthly deposition rates for the reporting period were between 1.4g/m²/month and 2.3g/m²/month, which is significantly below the criteria of 4g/m²/month, indicating good air quality with respect to dust deposition. Currently there are no discernible trends.

No complaints were received and no reportable incidents relating to air pollution occurred during the reporting period. However, as evident from **Table 7**, the bottles for deposited dust monitoring were not changed monthly. This was partly due to miscommunication with the laboratory resulting in incorrect bottles, funnels and plugs being supplied to Austral and a focus of meeting requirements for physical commencement. As noted in Section 1 and discussed in Section 11, this is considered a non-compliance with the required monitoring frequency. However, improvements in air quality monitoring practices were implemented in May 2017 with monthly sample changes occurring since that time.

Therefore, no further improvements relating to air pollution are currently planned or considered necessary. However, focus will be placed on continuing to ensure that dust gauge bottles are changed monthly. Additionally, with to the planned commencement of earthmoving and extractive activities, management controls during the next reporting period will be implemented consistent with the approved Air Quality Management Plan.
